## **Failure Analysis in Space: International Space Station (ISS) Starboard Solar Alpha Rotary Joint (SARJ) Debris Analysis**

Space Shuttle mission STS-117 delivered the S3/S4 truss segment to the ISS, which included a SARJ that rotates 360° to position the solar arrays facing the sun. Three months after installation, vibration was observed in a camera mounted on the SARJ, and an investigation commenced to find the source. Debris was collected from the starboard SARJ during an extra-vehicular activity (EVA) of STS-120 and returned to the Kennedy Space Center so that a remote failure analysis could be performed on Earth. A plan was formulated to identify the source of the debris and to determine the failure mechanism. This presentation will show the data from the analysis—including stereomicroscopy, scanning electron microscopy, energy dispersive spectroscopy, and laser confocal microscopy—and interpret the data in support of the failure analysis. The debris originated from the race ring and failure of the fragments appeared to be the result of contact stress fatigue.

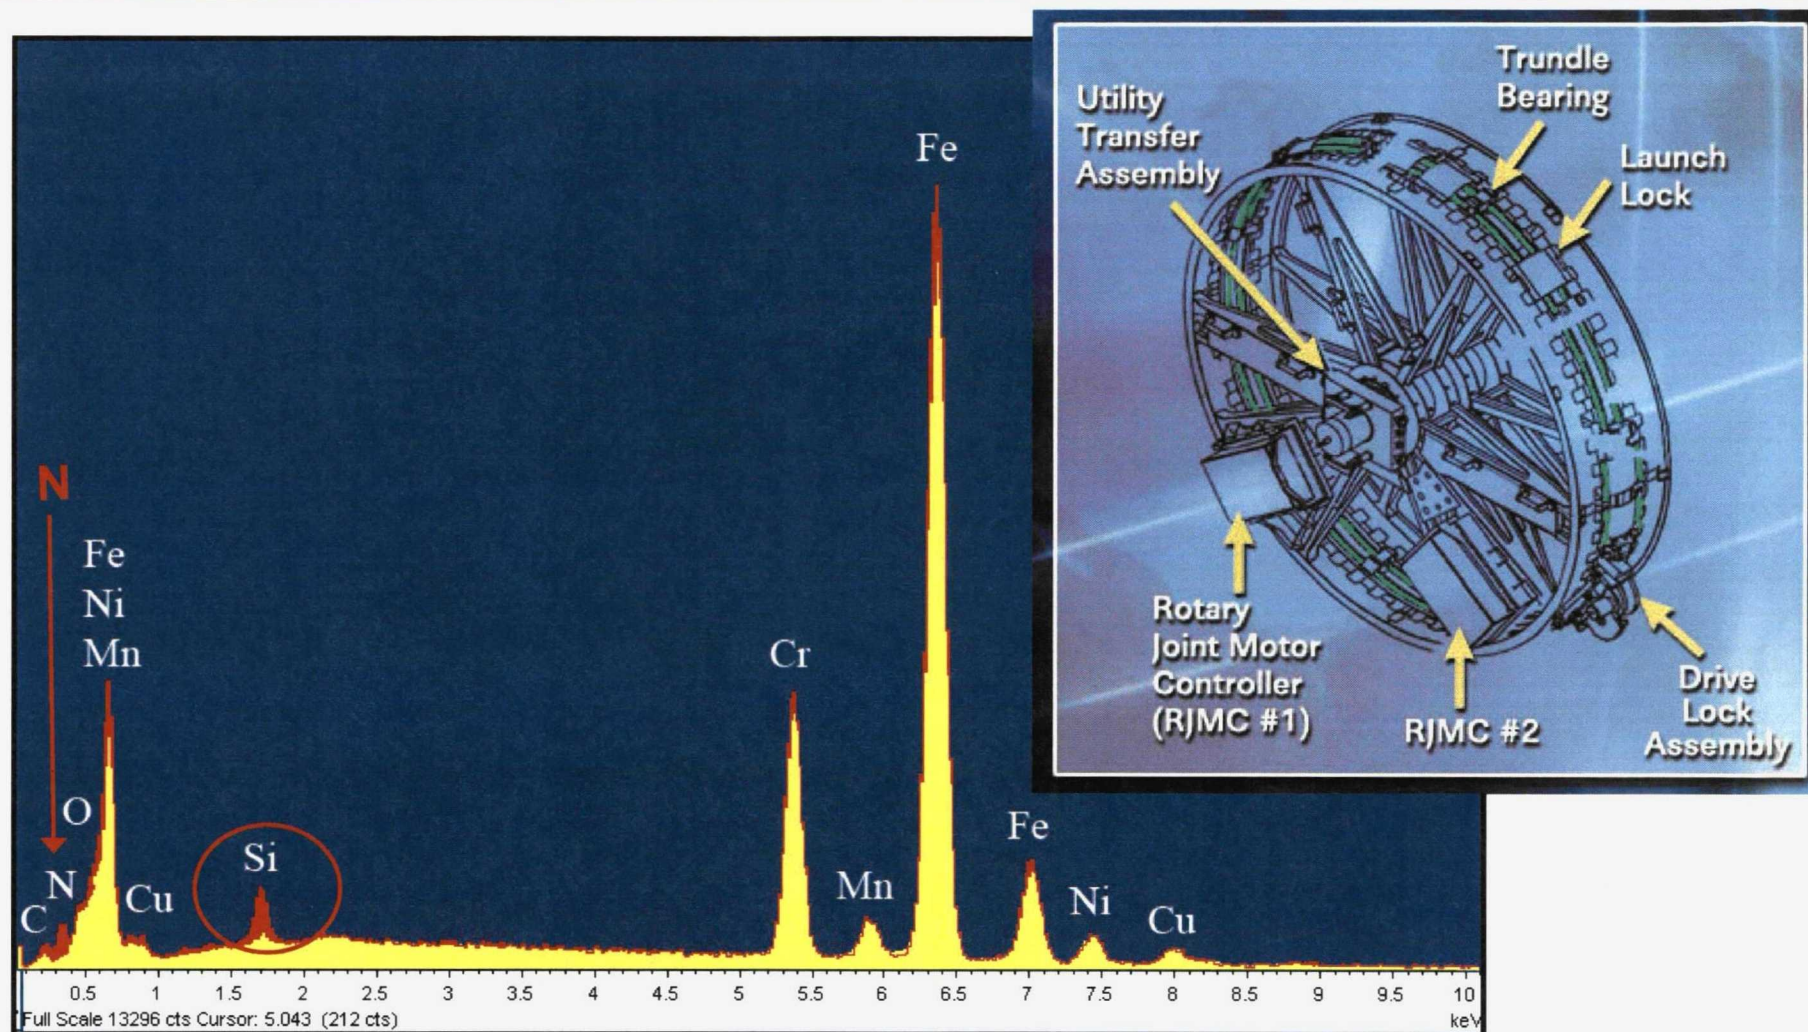
Overlay of representative spectrum from debris (red) on the baseline 15-5 PH spectrum. Nitrogen peak indicates that the debris is from the nitrated layer. The silicon peak is from the silicone adhesive used on the sampling tape.

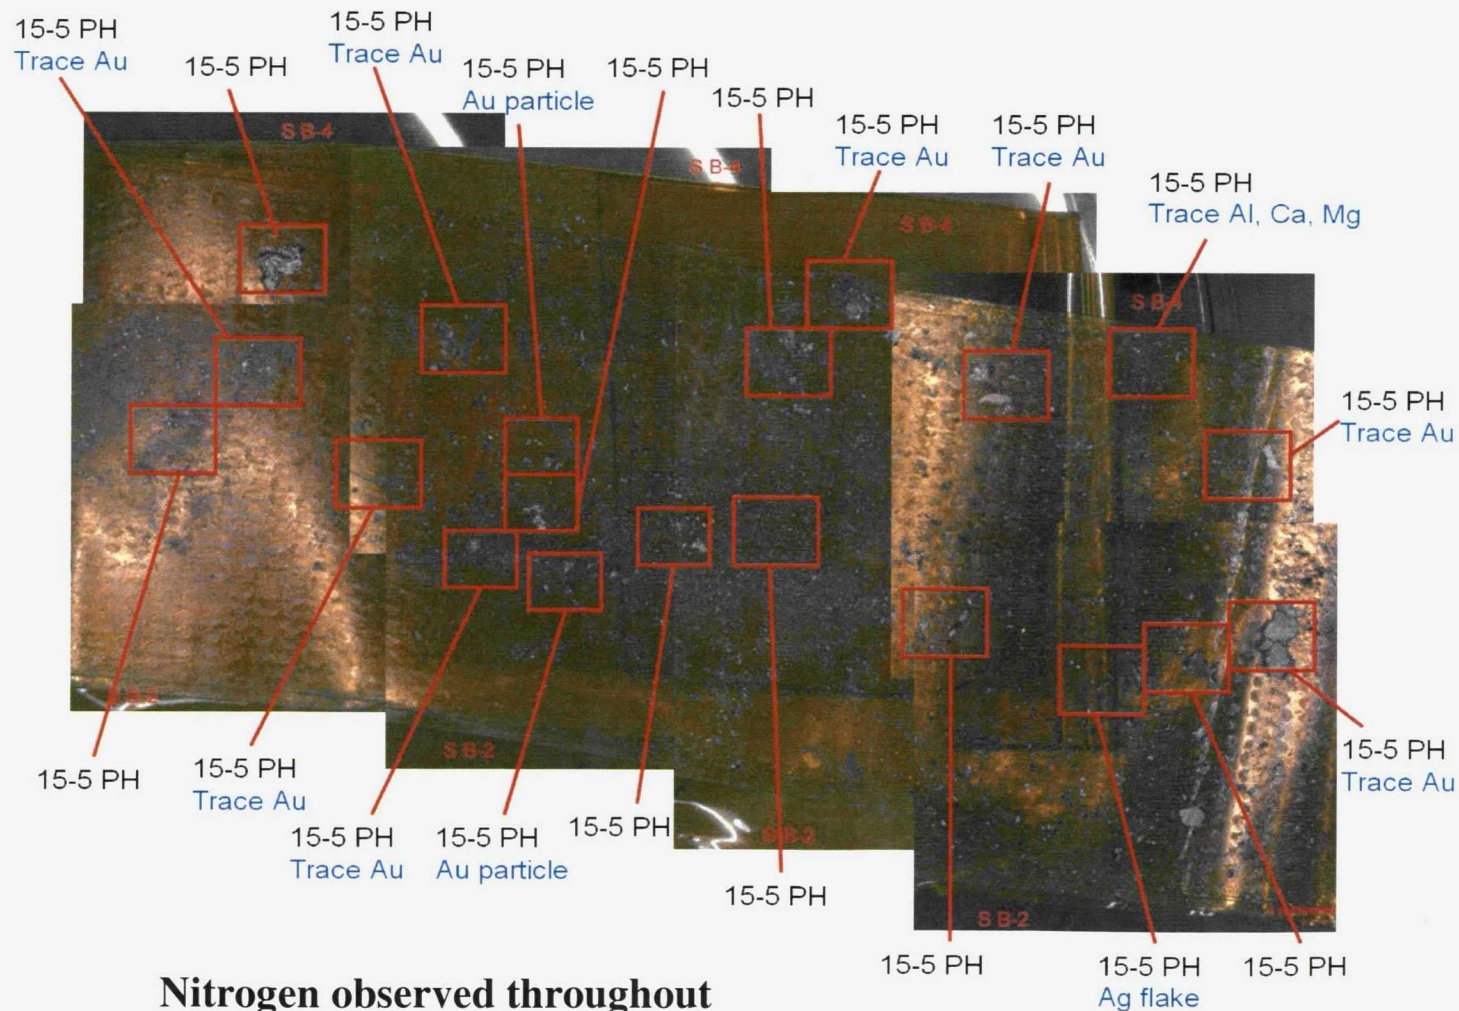
Representative tape showing the analysis locations. The majority of the particles were nitrided 15-5 PH stainless steel.

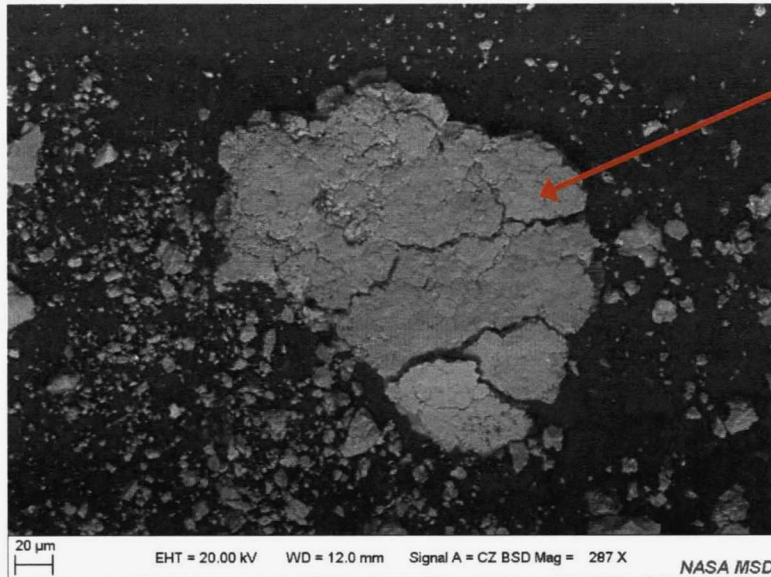
Gold particle  
showing  
atomic  
contrast.

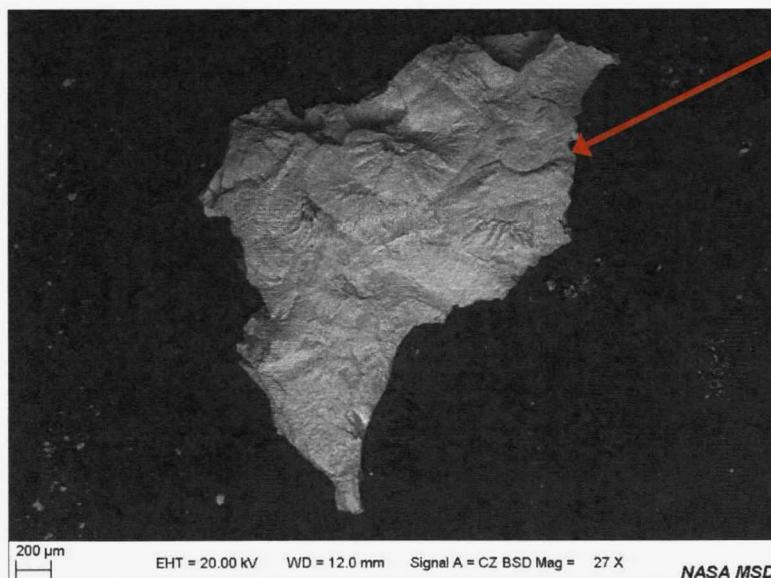
Original 15-5  
PH nitrided  
surface with  
machine  
markings.

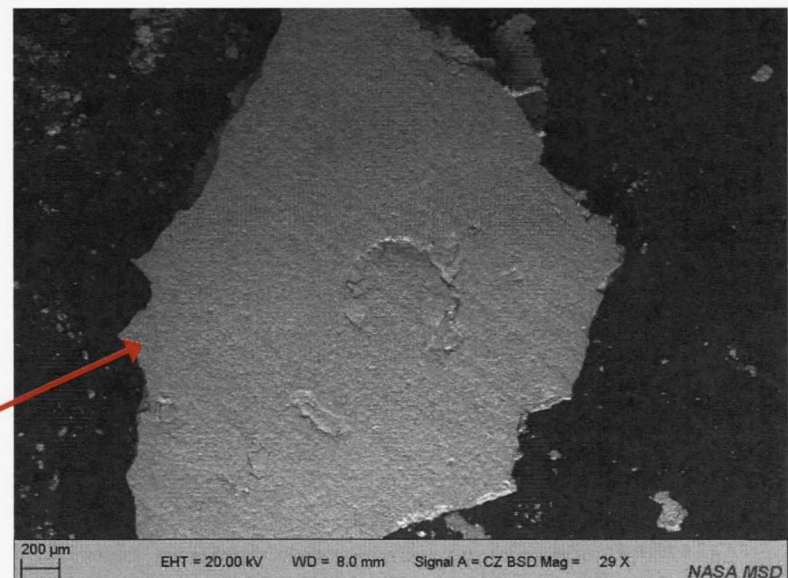
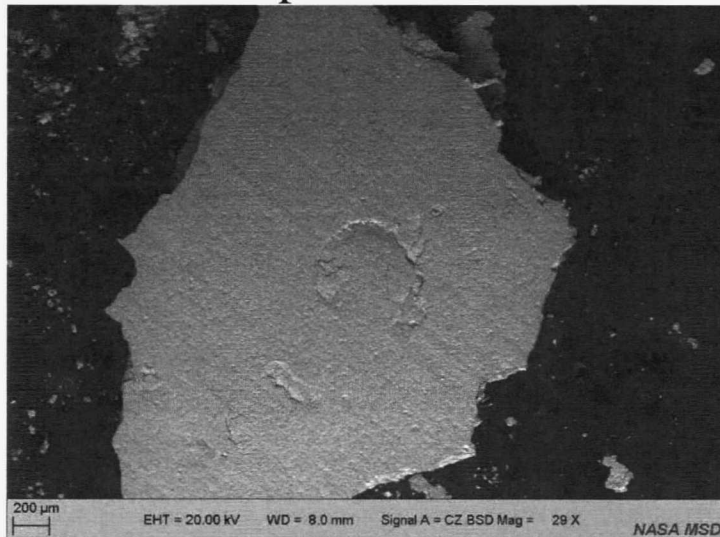
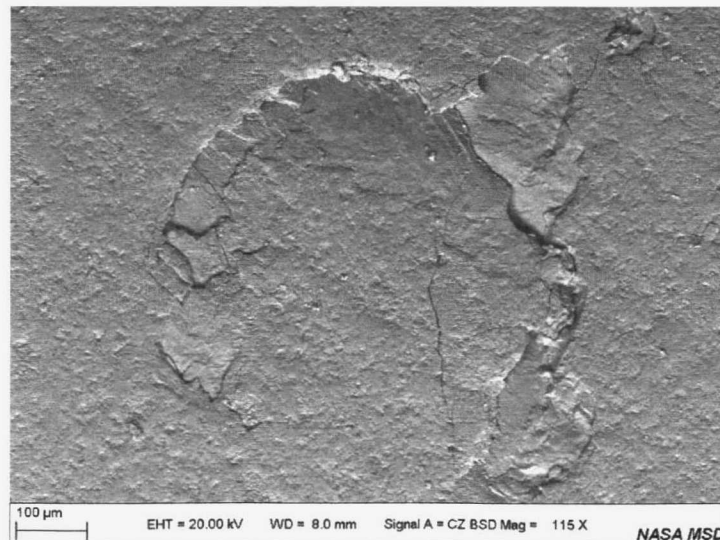
Nitrided 15-5 PH  
surface with  
machine markings  
on obverse (L)  
and flipped over  
revealing  
scalloped reverse (R).

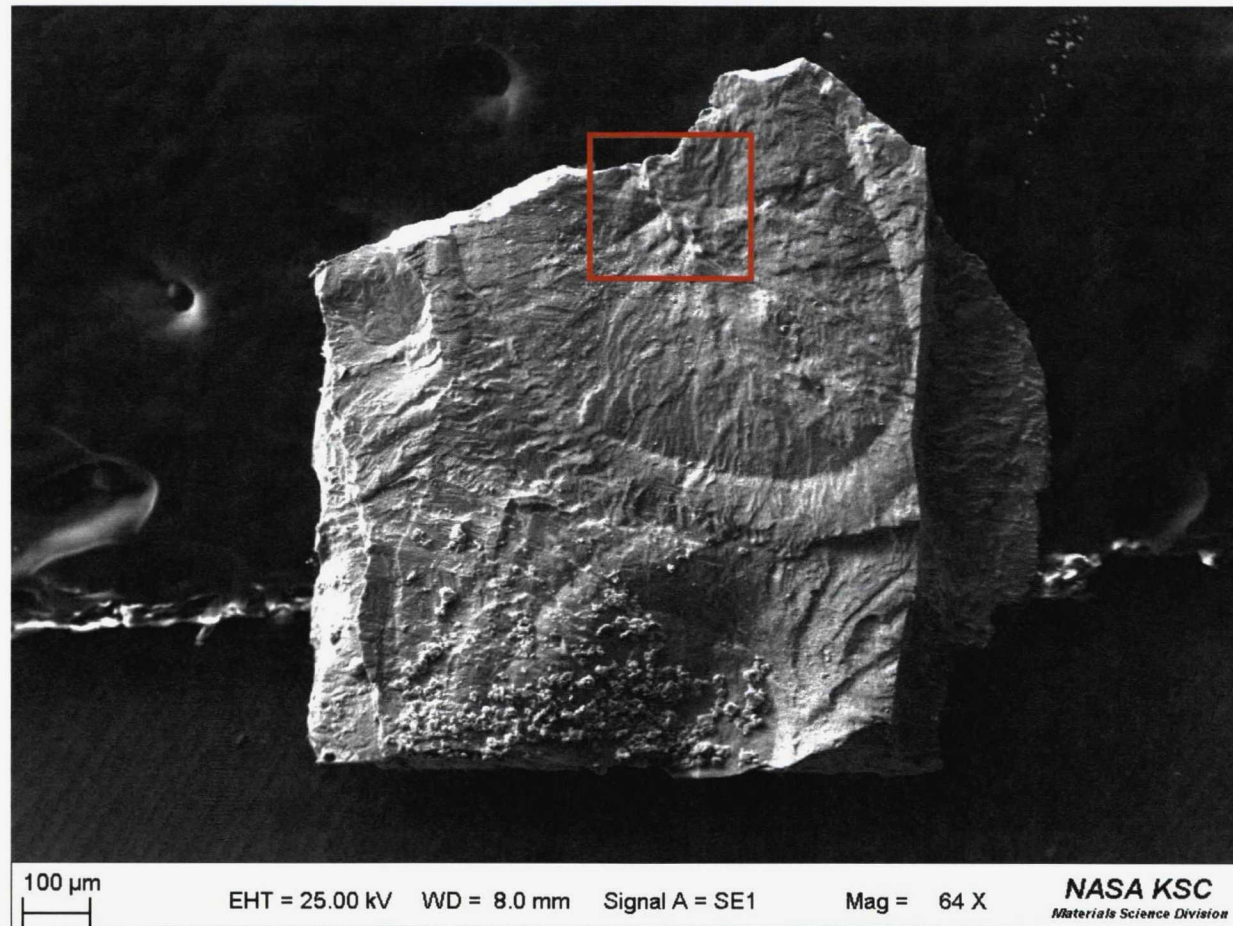
Secondary electron (SE) SEM image of a fragment removed from tape and imaged under high vacuum.

Area in red box appears to be a fracture initiation site and elliptical region suggests crack arresting. Features typical of spalled fragments.

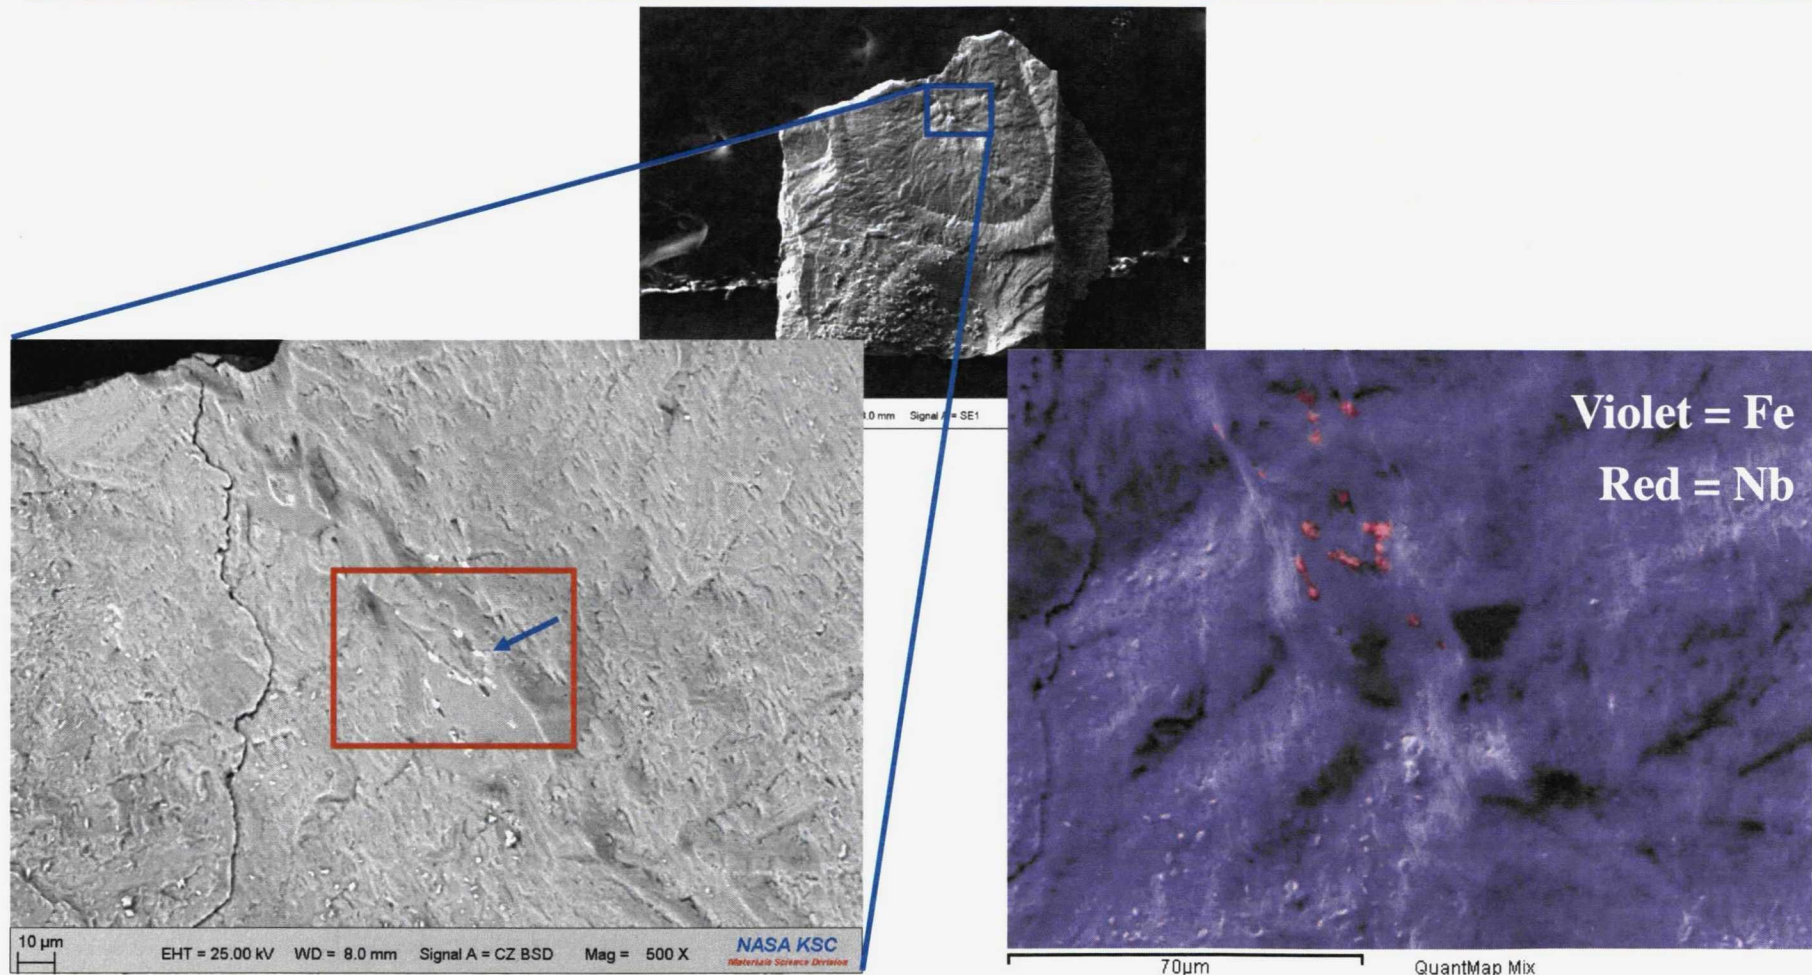
Backscattered electron image of outlined area in red box from previous slide showing atomic contrast.

X-ray elemental dot map of the boxed area, showing niobium-rich precipitates in an iron-rich matrix.

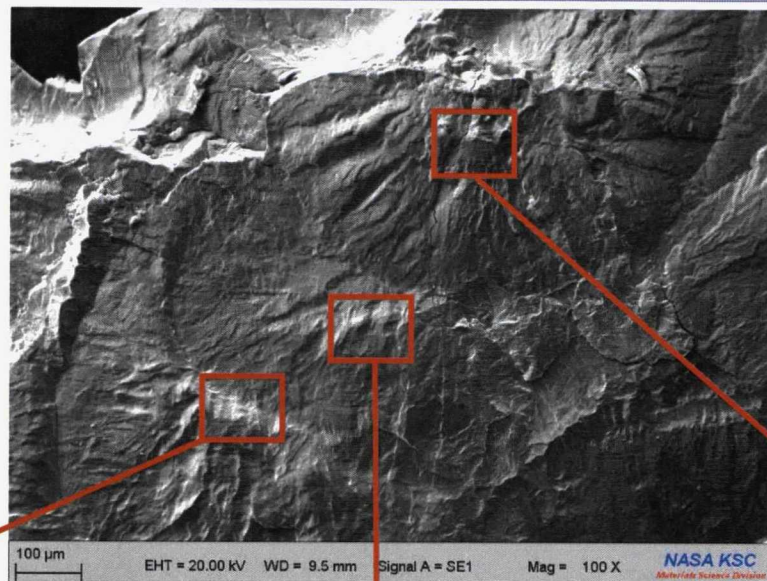
Backscattered electron image showing atomic contrast of the niobium-rich precipitates at typical subsurface fracture initiation sites.

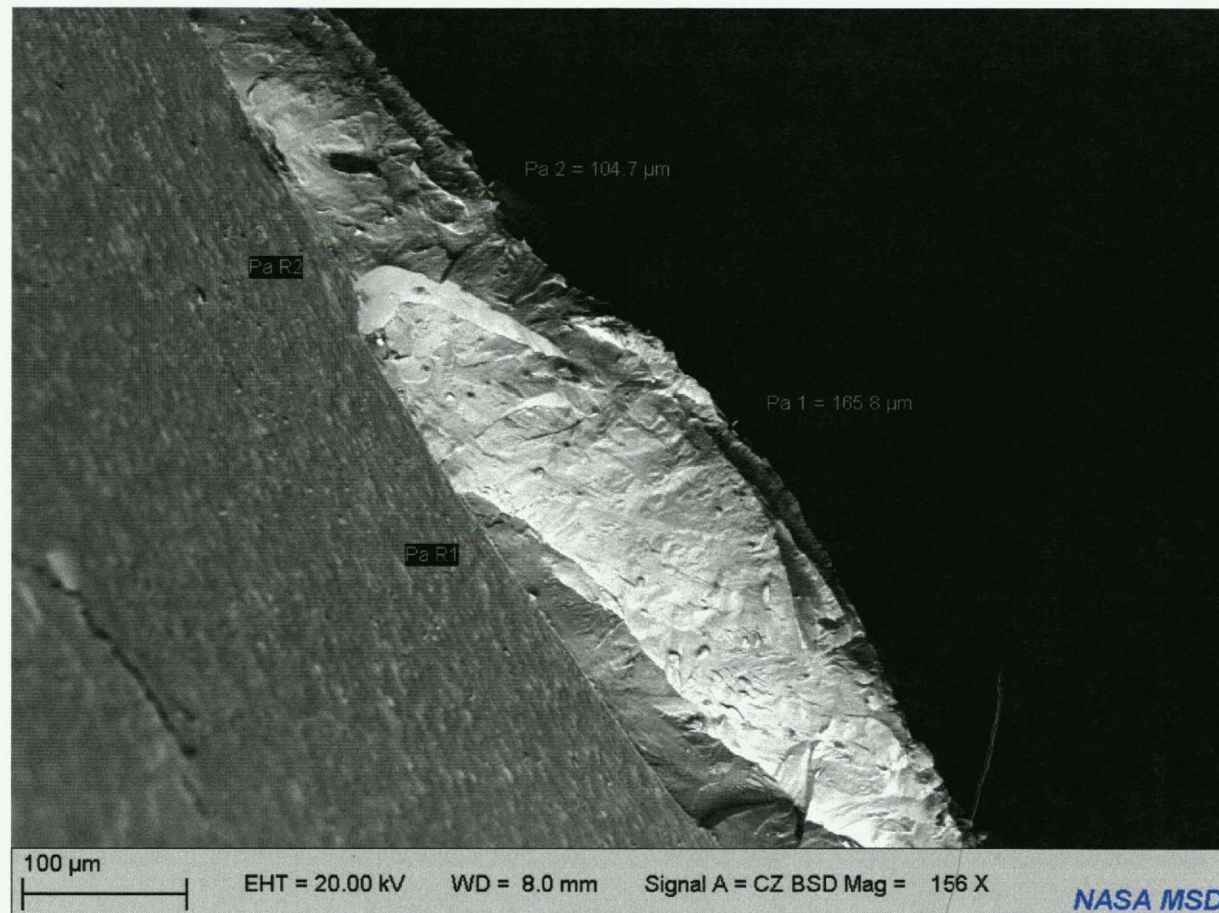
Particle thickness measurements of a large particle in the SEM correlated with measurements taken using laser confocal microscopy, which were 100 to 165  $\mu\text{m}$  for this particle.

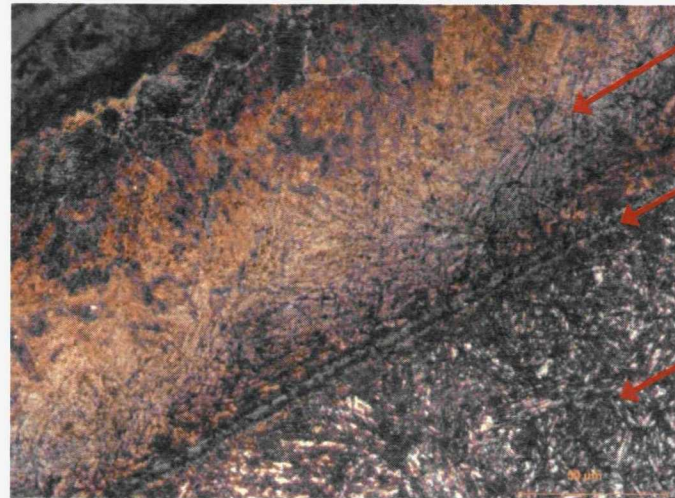
SARJ fragment  
cross section.

Nitrided case (120  $\mu\text{m}$ )

Interface

Martensitic core

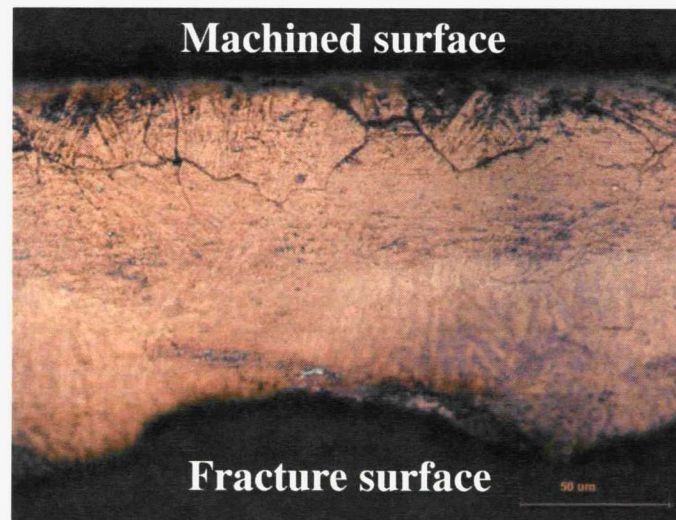
No martensitic core was  
observed in SARJ  
fragment.

Microhardness of the mounted cross section was converted to approximately 71 Rockwell C (HRC).

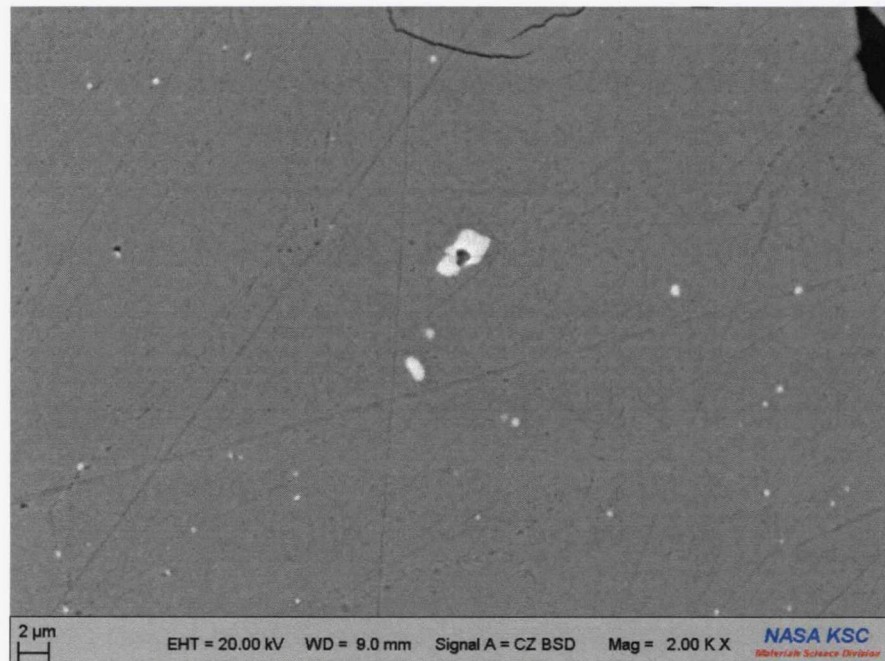
The precipitates in the SARJ fragment were similar in size and distribution to stock 15-5 PH stainless steel.
